DOT HS 808 305

June 1995

Final Report

# **Moving Deformable Barrier into Left Side of 1995 Solectria Force at 52.9 kph.**

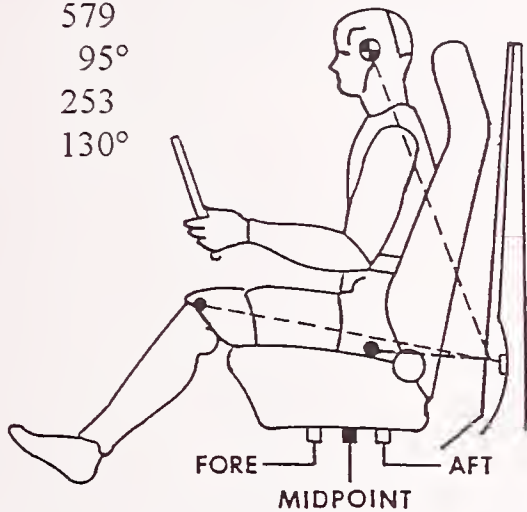
Driver Dummy<sup>1</sup> #199; Type: SID

Head 471  
 Target -50°  
 Knee 579  
 Joint 95°  
 Approx. 253  
 H-point 130°

<sup>1</sup> Driver dummy measurements are referenced to top of front door striker.

All distance measurements are in millimeters.

All angles are referenced to vertical.

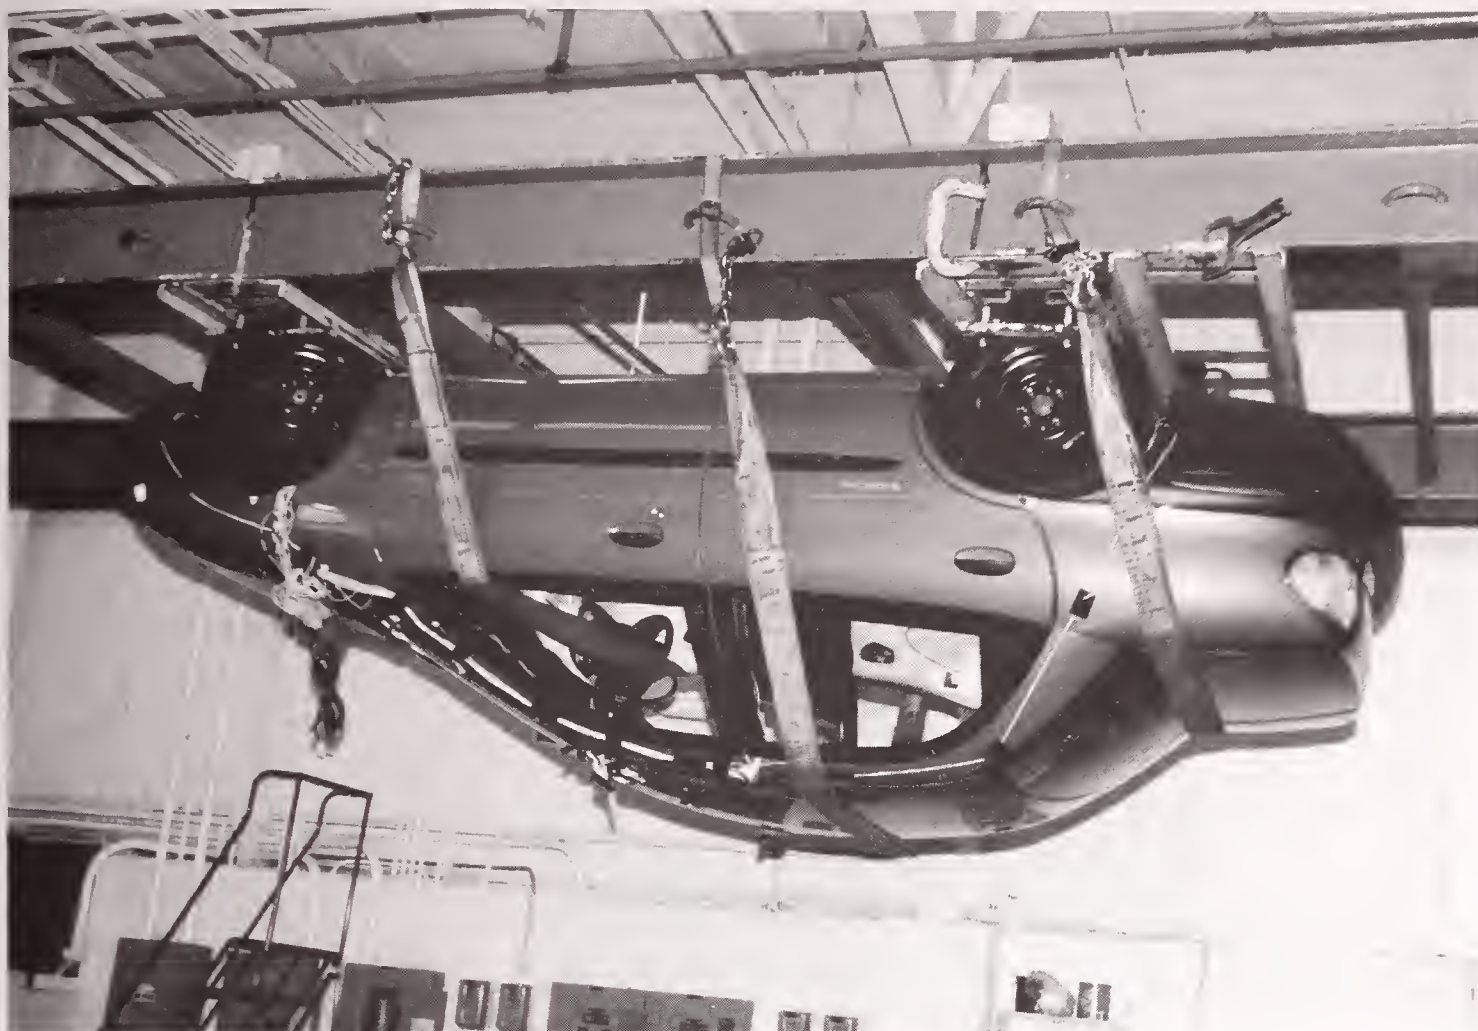
Figure A-32 Post-test Vehicle on Static Rollover View

The vehicle's left side doors did not separate from the body. The vehicle's right side doors did not open during the impact. No electrolyte was found in the passenger's compartment after completion of the static rollover test.
